Deaths due to “patpat” accidents in the Black Sea Region, Turkey

METHODS: A patpat is a single-axle, two-wheeled tractor with a trailer attached. In this descriptive study, the descriptive characteristics and causes of death were analyzed of case related to patpat accidents for which autopsies were performed by the Forensic Medicine Institution Trabzon Group Directorate between 2006 and 2017.

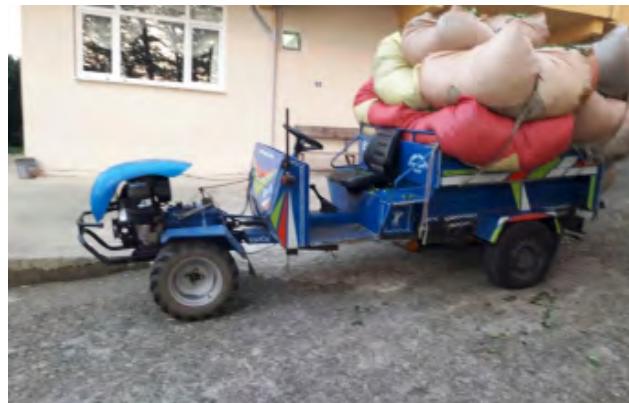
loads. Overtime, agricultural machines have been designed appropriate to more simple needs, instead of tractors which have a wide area of use. An example of these is the “patpat,” so named because of the sound of the motor, and for which the main purpose is ploughing. A patpat is a single-axle, two-wheeled tractor with a trailer attached^[1] (Fig. 1).

Figure 1. An example of a patpat used for carrying loads.

By changing the original structure, patpats are newly designed agricultural vehicles for use on rough ground and in narrow areas that are not suitable for bigger vehicles such as tractors. These agricultural vehicles are produced with a single cylinder motor and generally 10–22 horsepower, and are modified to local needs in workshops partially specialized to the region, for use in field irrigation. Patpats which are used by attaching two separate gears to the motor are not accepted under the existing laws in Turkey as a "motor vehicle," and therefore have no number plate, license, and requirement for periodic checks for roadworthiness and are not subject to motor vehicle tax. Moreover, because of the features as an agricultural machine, patpats are forbidden in road traffic.^[2] Most patpat users do not have a driving license and the vast majority have been reported to have an education level of primary school. These vehicles are preferred by farmers as they are cheap, do not require a driving license, and do not entail expenses such as tax and insurance.^[3,4] Similar agricultural vehicles are still used with modifications in countries such as Russia, Macedonia, Afghanistan, and Pakistan.^[2]

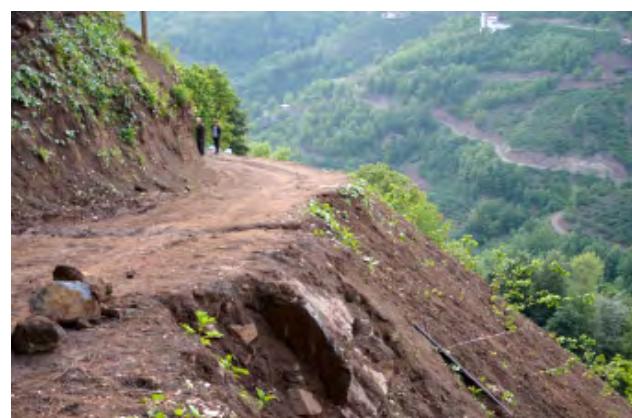
Figure 2. The steep unmade roads in the fields and rural areas in the region (real accident scene image).

it has become necessary to use patpats in relatively small agricultural areas because of the mountainous, rugged features of the land and the rainy climate (Fig. 2). Due to the geographical features of the region and the use of patpats other than for agricultural activities, the likelihood of accidents increases. The previous studies in literature have reported injuries and deaths as a result of patpat accidents.^[2-5]

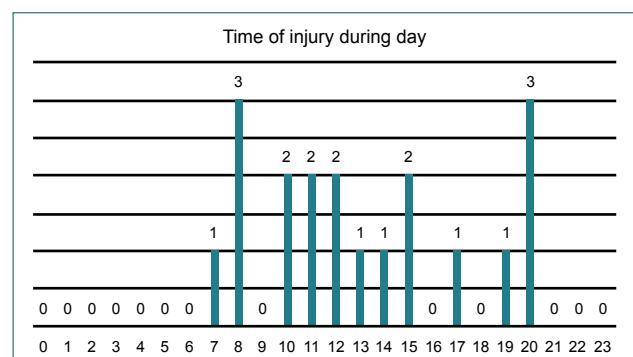
Figure 3. Time of injury during day.

of a patpat accident. The 21 cases comprised 17 (81%) males and 4 (19%) females, with a mean age of 47.6 ± 20.3 years (median: 57, range: 10–75 years). Of the total accidents, in 85.7% (n=18), no other vehicle was involved. The times of the accidents are shown in Fig. 3.

Of the accidents in the current study, 90.5% (n=19) occurred between the times of 07.00–21.00 h, and the time of the accident was not reported in the documents in two cases. The times at which the accidents occurred are consistent with travelling to and from work, especially during planting and harvesting seasons. The body areas most frequently injured in patpat accidents were the head and neck at a rate of 60% followed by the chest. As shown at Figures 7a and b, the main causes of fatal patpat accidents were traumas of head and chest. The abdomen was also another target as shown at Figure 7c with a laceration of liver. Like our study, the causes of deaths related to tractor have been reported to be mainly trauma to the head and chest regions also.^[5,8,11–13]

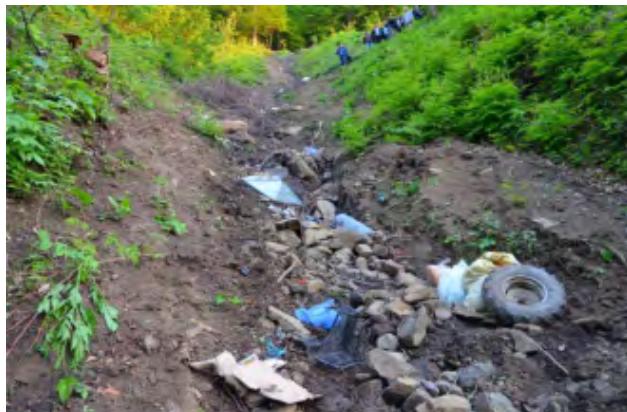
Figure 4. A patpat that breaks into a large number of pieces due to rolling over the abyss.

conditions where they are used. According to the scene of accident reports, 85.7% (n=18) of the patpats in this study were found to be overturned or on their side following the accident. This is also seen as significant in tractor accidents, with overturning of the vehicle responsible for approximately half of tractor deaths.^[6,7] The high rate in the current study can be attributed to serious problems related to the safety of the users of patpats produced from other vehicles in an uncontrolled and unsupervised manner. As no differential is used in these vehicles, the two wheels turn at the same rate going round a bend and this can cause the patpat to overturn.

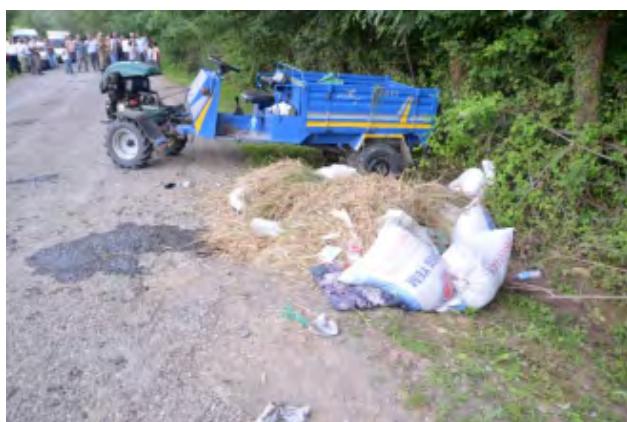
Figure 5. A patpat that has been knocked over because of roll over.

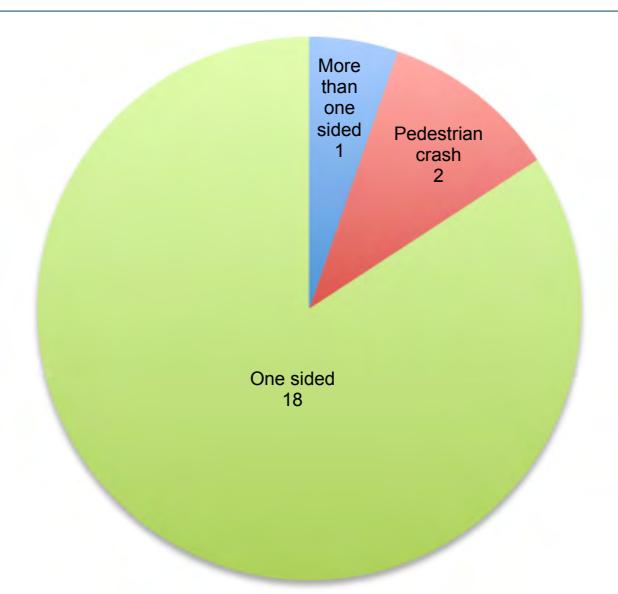
Following the accident, 52.4% (n=11) of the patpats were found at the side of the road, and 33.3% (n=7) at the edge of a stream or at the bottom of a steep valley. The cause of the accident was determined to be that the patpat had overturned on a bend in 33.3% (n=7) cases and in 85.7% (n=18) of cases, the patpat was found overturned or on its side. Two different images of patpat accident can be viewed at Figure 4 and 5. The most common injury was being thrown from the vehicle (38.1%, n=8), and in 66.7% (n=14) of cases, the deceased was the patpat driver. Ethyl alcohol (116 mg/dL) was determined in the blood of only one case. The information related to the accidents is shown in Table I and Figure 6.

Figure 6. Type of accident.

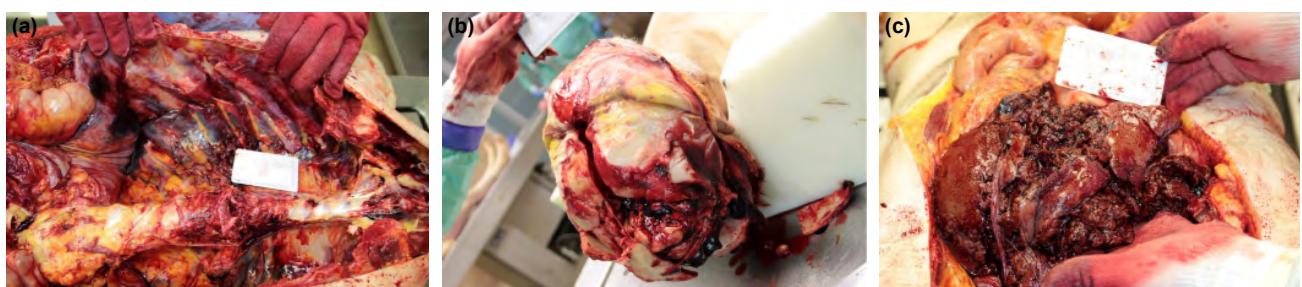
Three different autopsy findings have been presented at Figure 7a (multiple costa fracture after severe blunt trauma

and displaced thoracic vertebral fracture causing complete rupture in the medulla spinalis), Figure 7b (diffuse intracerebral hemorrhage, contusion and laceration, and discrete fragmented skull fracture), and Figure 7c (widespread laser appearance in the liver) (Figs. 7a-c).

Figure 7. (a) Multiple costa fracture after severe blunt trauma and displaced thoracic vertebral fracture causing complete rupture in the medulla spinalis. (b) Diffuse intracerebral hemorrhage, contusion and laceration, and discrete fragmented skull fracture. (c) Widespread laser appearance in the liver.
